THERMO-MECHANICAL CHARACTERIZATION OF
SILICON CARBIDE-SILICON CARBIDE COMPOSITES
AT ELEVATED TEMPERATURES USING A UNIQUE
COMBUSTION FACILITY

DISSERTATION

AFIT/DS/ENY/09-S01

AIR FORCE INSTITUTE OF TECHNOLOGY

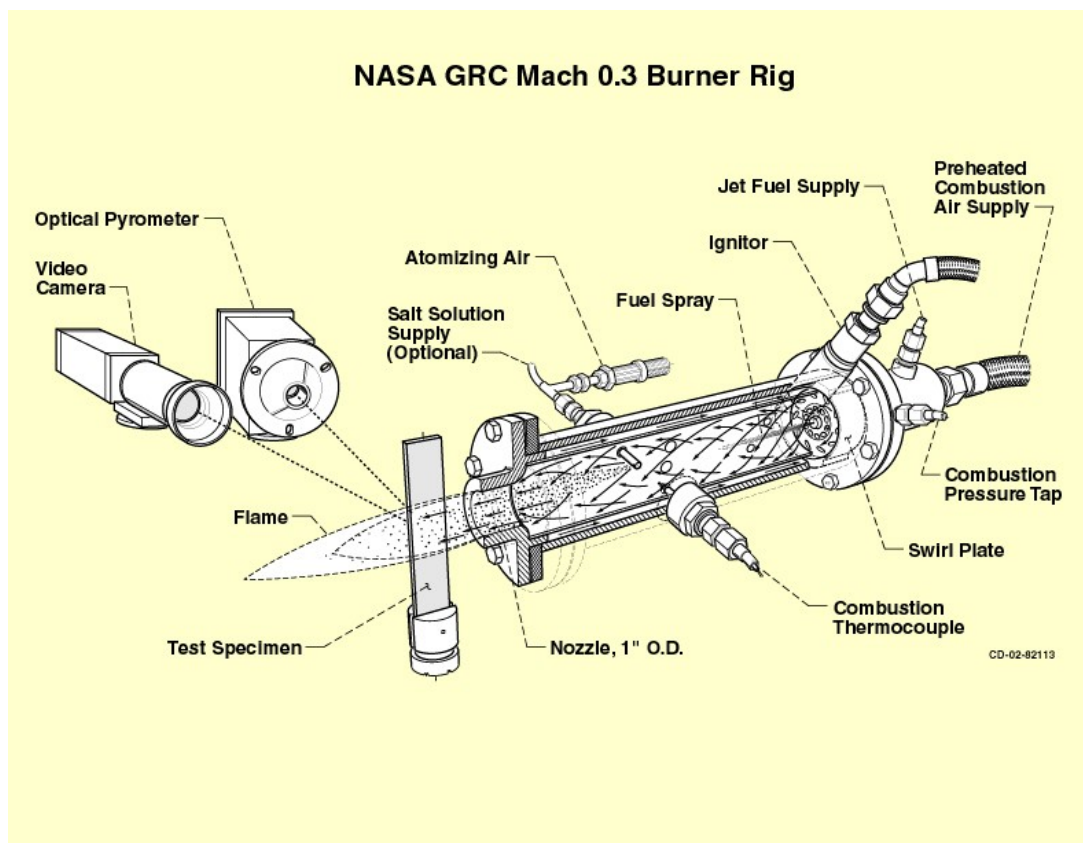
Figure 5 : Schematic of the 0.3 Mach APBR at NASA Lewis Research Center [65]

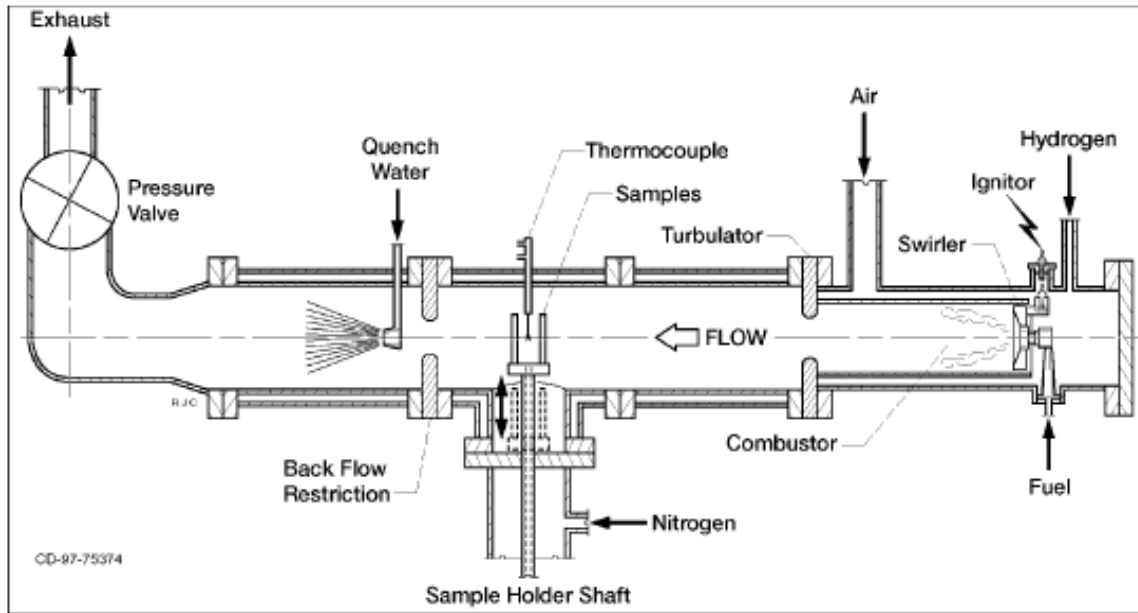
Figure 7: Schematic of the High Pressure Burner Rig (HPBR) [58]

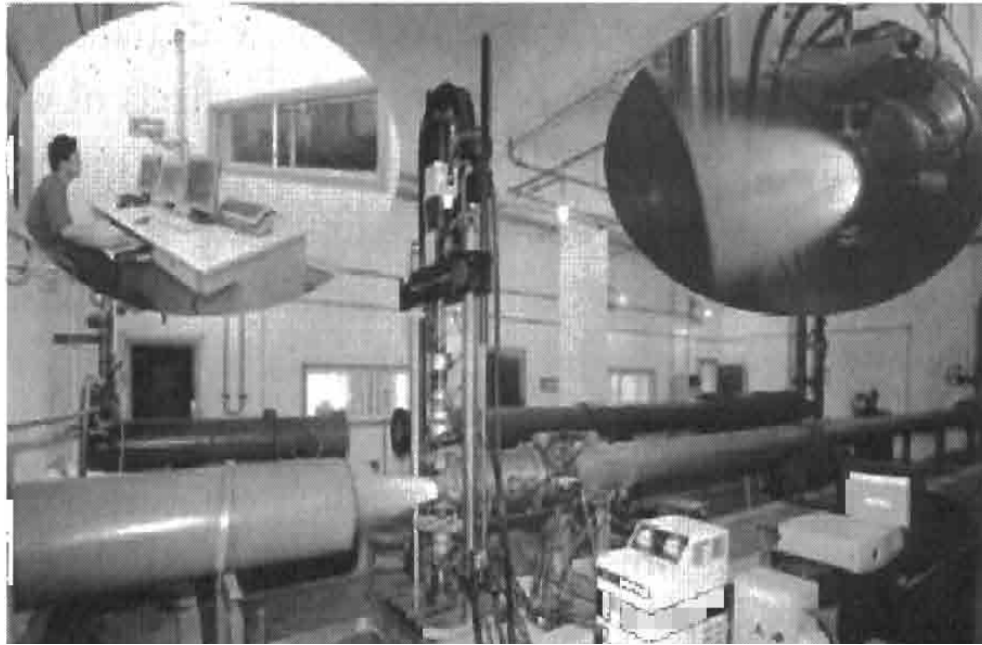
Figure 9: Wind tunnel experimental system at Northwestern Polytech University in China

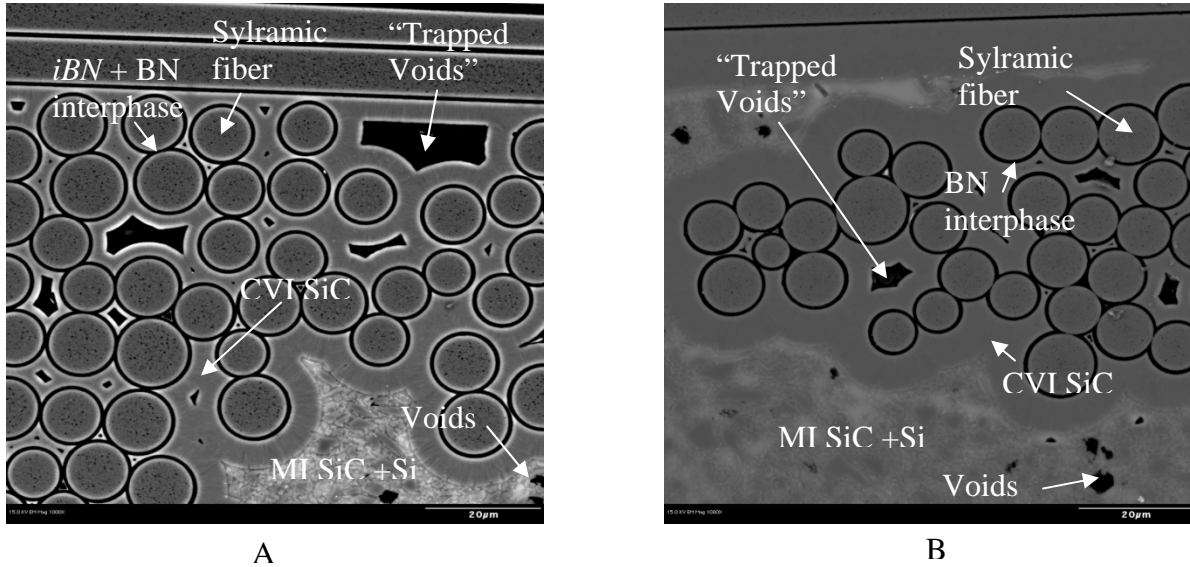
Figure 11: Microstructure of pristine samples; (A) woven MI Syl-iBN/BN/SiC and (B) woven MI Syl/BN/SiC

Sylramic fiber adds to creep and oxidation resistance over as-produced Sylramic fiber, as the *iBN* serves as a buffer layer that reduces detrimental mechanical interactions between contacting fibers [22]. Figure 11A & B show the SEM of the pristine woven MI Syl-iBN/BN/SiC and woven MI Syl/BN/SiC taken in backscattered electron mode (BSE). Along with the CMC constituents, also depicted in the figure are the voids that have been sealed off during CVD processing surrounded by CVI SiC matrix on 90° tows as shown in Figure 11, defined here as trapped voids

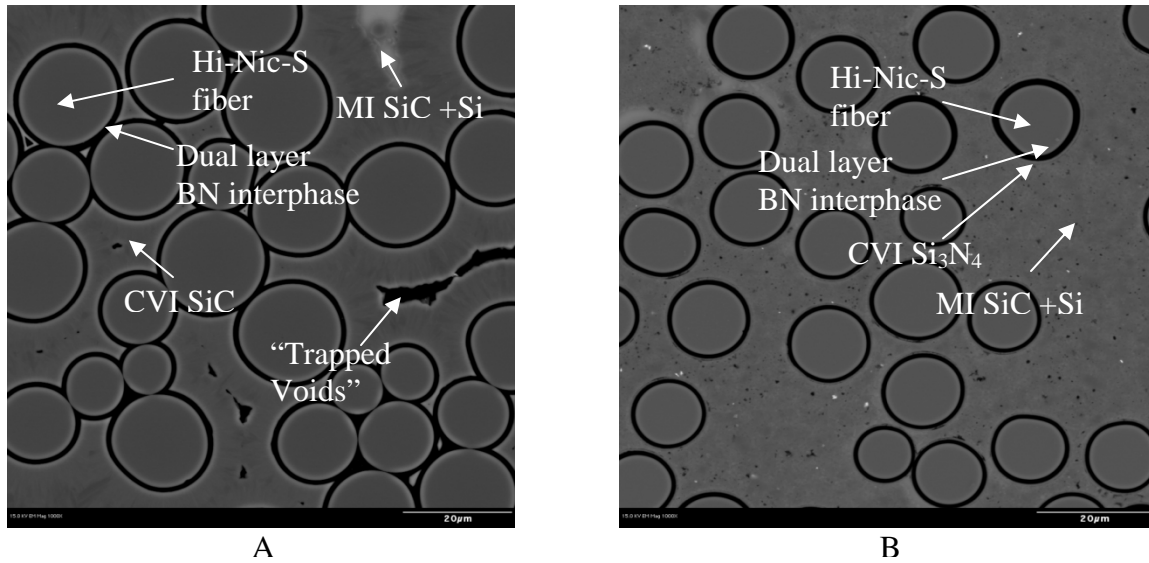
Figure 15: Microstructure of pristine materials; (A) woven MI Hi-Nic-S/BN/SiC and (B) Prepreg MI Hi-Nic-S/BN/SiC

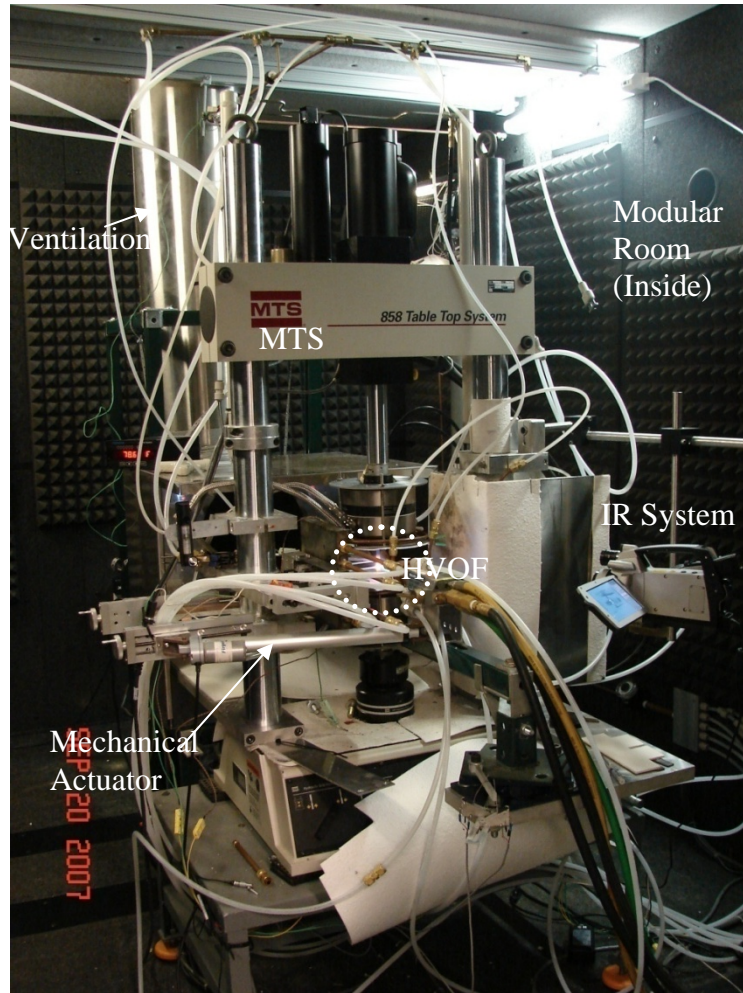
Figure 20: (a) AFIT/AFRL burner rig in operation; (b) encircled area in (a) zoomed in

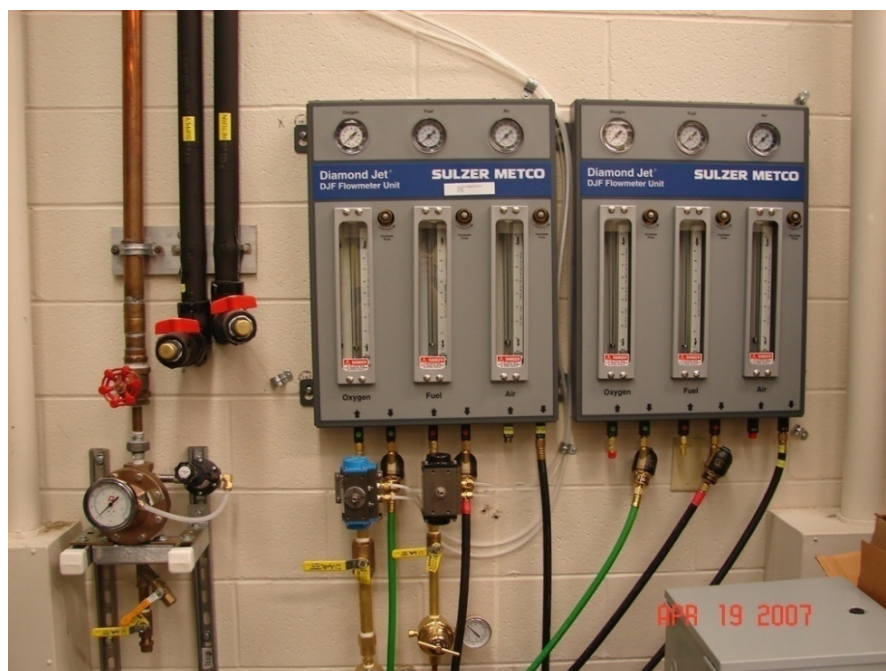
Figure 26: Flow controllers equipped with safety devices

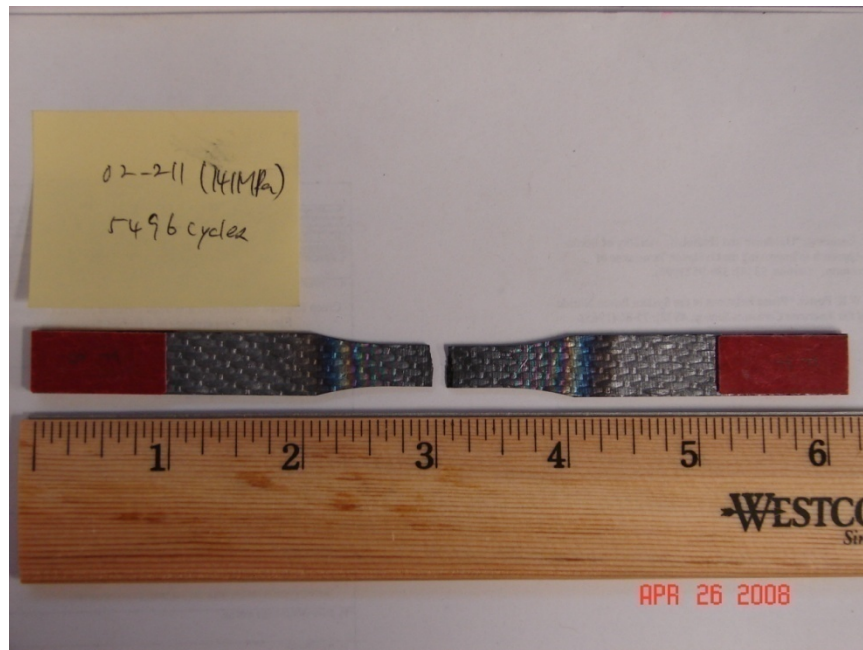
Figure 32: Fractured specimen after test (woven MI Syl-*i*BN/BN/SiC shown)

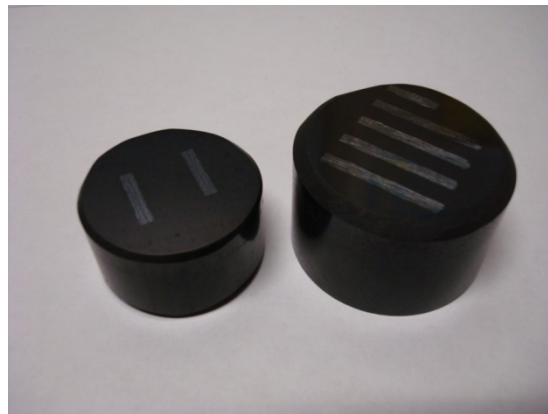
Figure 33: Polished specimen embedded in the mount

Sectioned surfaces were made from both the fractured and as-received samples. They were mounted in conductive Polyfast™ mounting compound using either Buehler Simplimet 2000 or Buehler/Metasery Pneumet Mounting press and then polished using diamond paste polishing compound and polycrystalline diamond suspension and Buehler Perforated Textmet polishing pads on either Pheonix 1000 or Ecomet 4 variable speed grinder polisher. The diamond particle size in the paste or slurry was 45 μm to begin polishing and progressively decreased to involve 9, 6, 3, 1, 0.05 μm in sequence, using the appropriate number of polishing pads designated for each size. As a final step, the polished surface was put in a Buehler Vibromet I polisher filled with colloidal silica slurry and Hyprez oil soluble (OZ) lubricant for 2 or 3 days. The finished surface was cleaned in distilled water and then cleansed using ultrasonic sonicator in acetone, followed by its immersion in distilled water before drying the surface using compressed air. Figure 33 shows two mounts embedding multiple sectioned surfaces of test specimens.

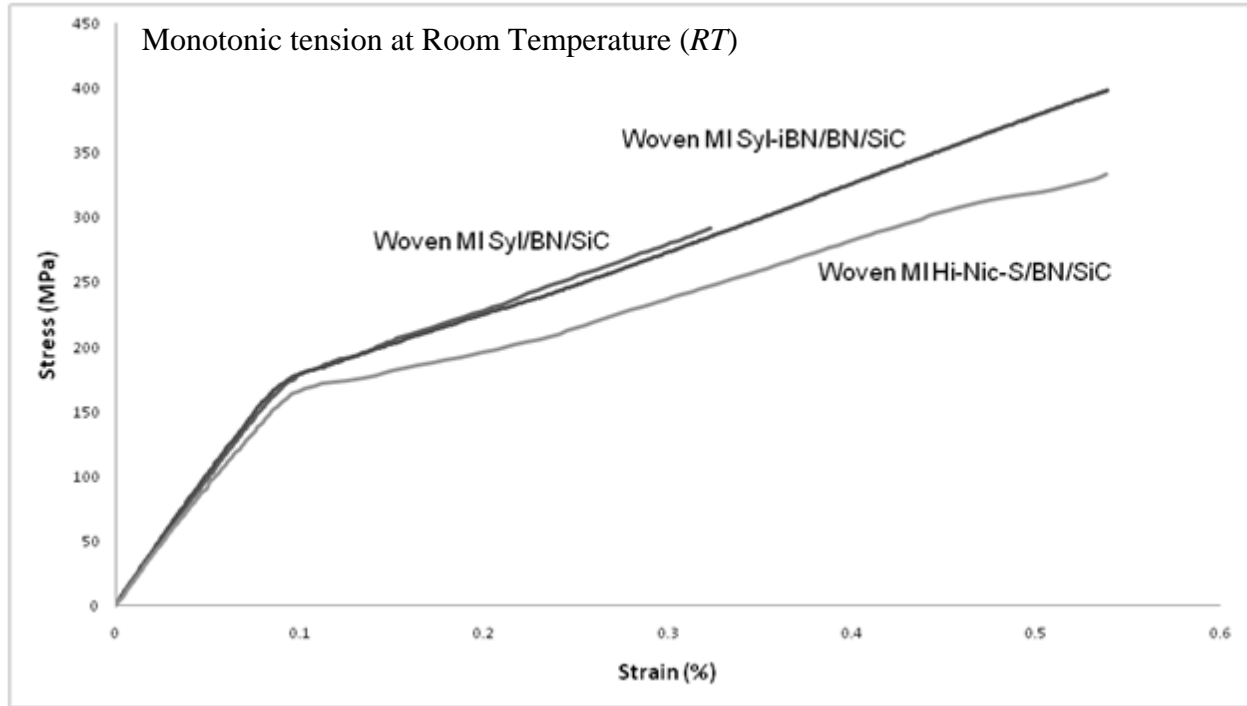
Figure 34: Room temperature monotonic stress-versus-strain curves [80,81]

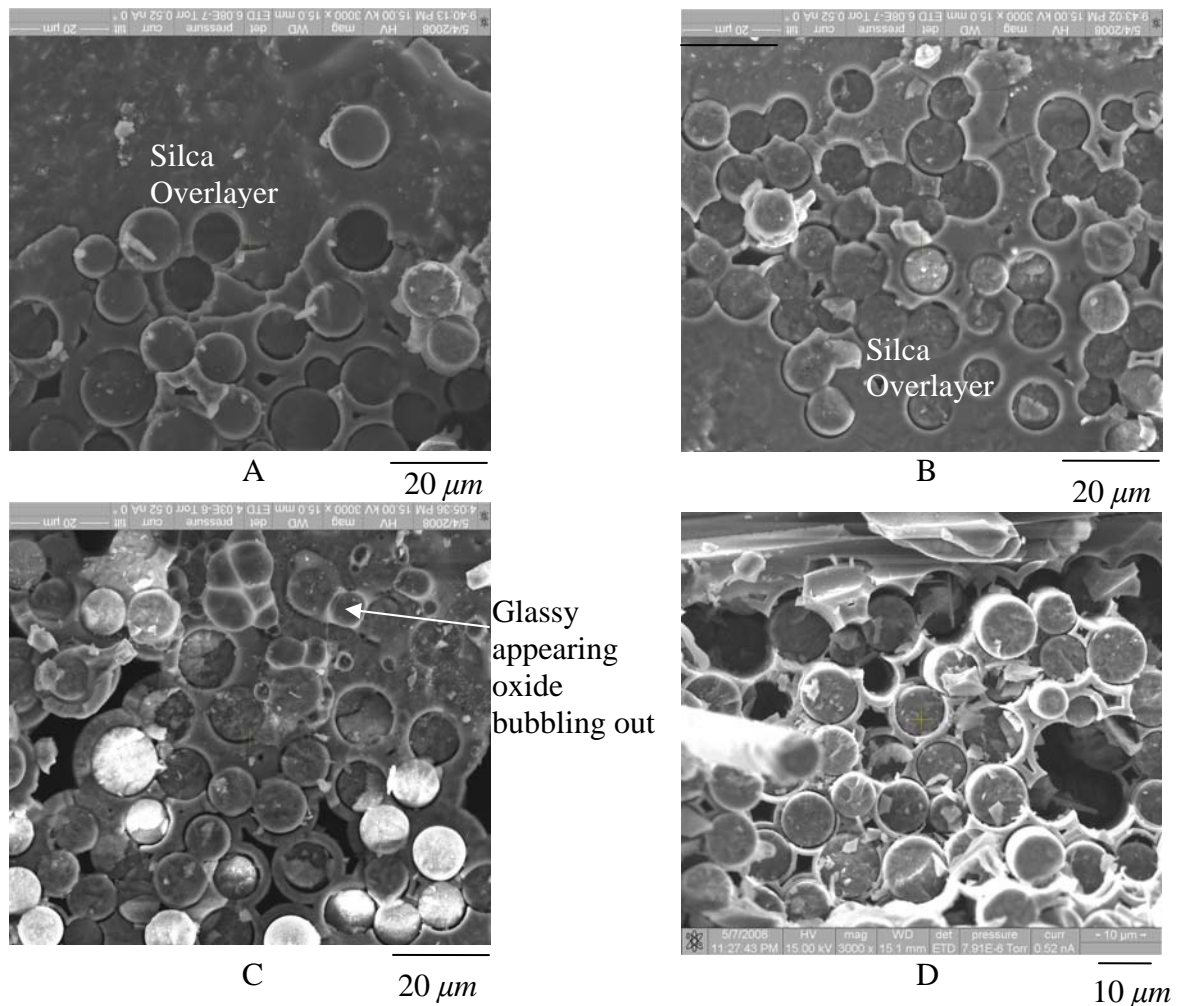
Figure 39: Microstructure of specimen fatigued at 112 % of PL : A, B and C are from the oxidized, and D is from the non-embrittled region. Their specific locations are pointed out on the fracture surface as denoted on Figure 37

with increased water vapor content [91]. Fiber pull-outs were observed in the non-embrittled region, as shown in Figure 39D and Figure 40G.

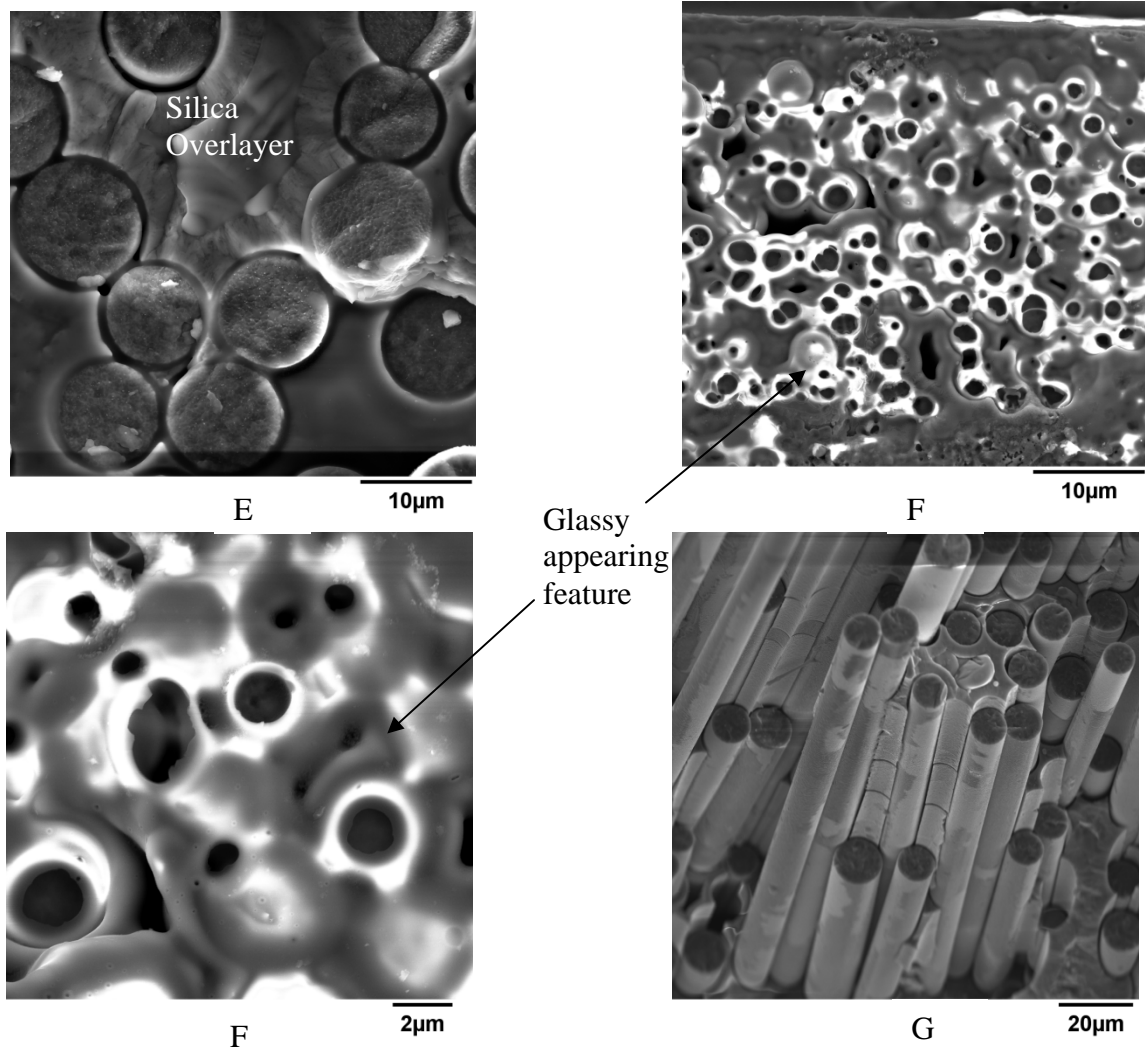
Figure 40: Microstructure of specimen fatigued at 75 % of *PL*: E and F are from the oxidized, and G is from the non-embrittled region on the fracture surface in Figure 37

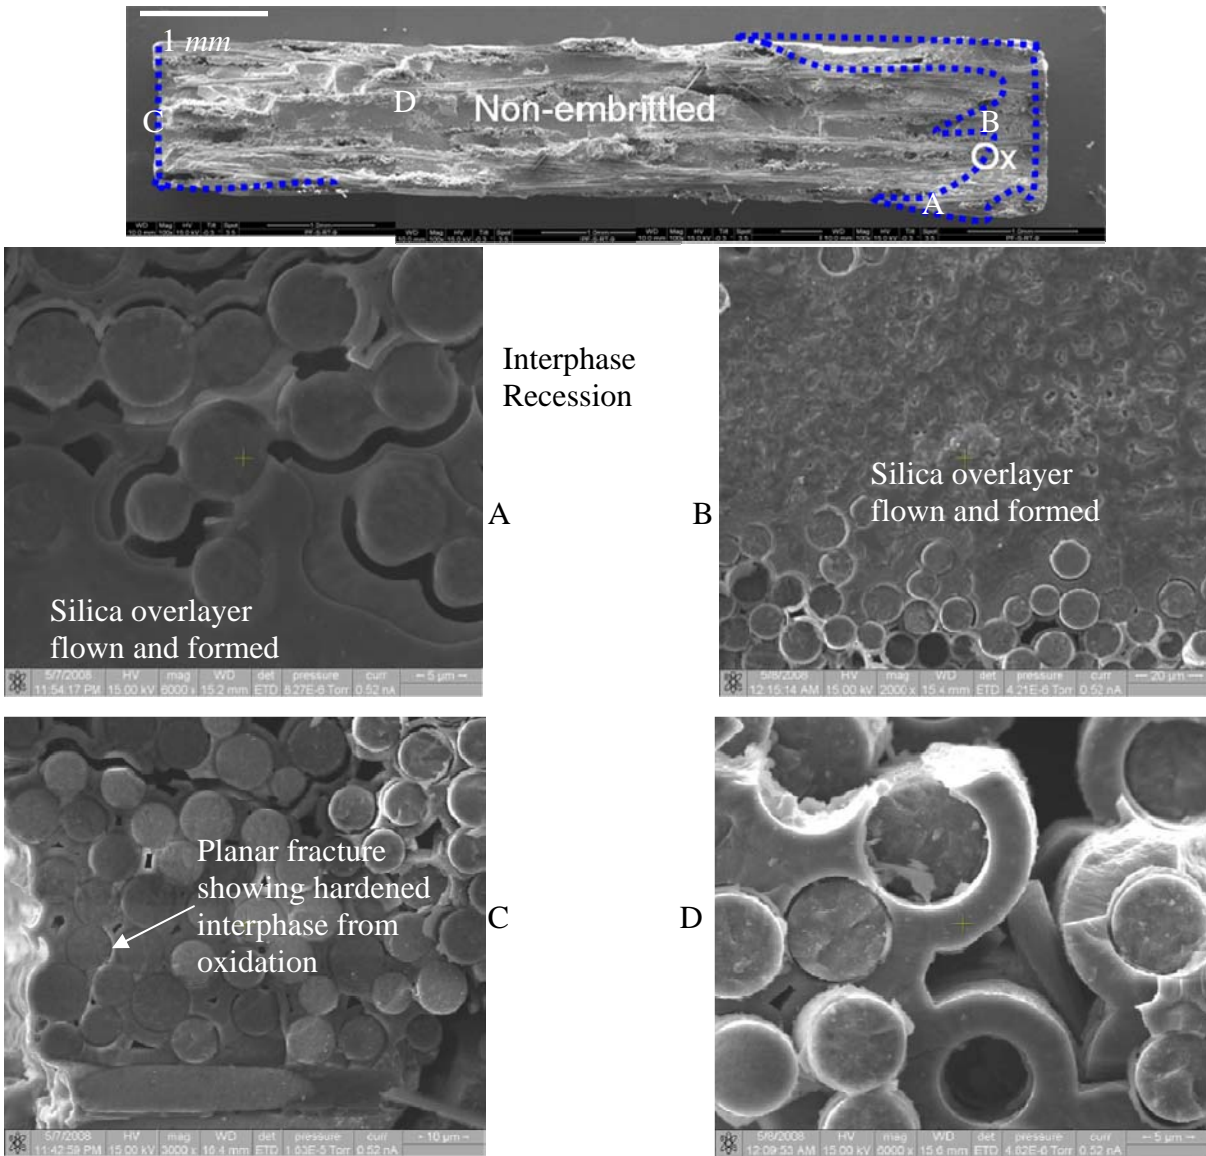
Figure 41: Microstructure of runout woven MI Syl-*i*BN/BN/SiC specimen after residual strength test

The fracture cross-section obtained from the residual strength test was at 19 *mm* above the geometric center of the specimen. The surface temperature at the cross-section of this fracture during the combustion test was measured to be $1088 \pm 38^{\circ}\text{C}$, $920 \pm 50^{\circ}\text{C}$ on the side surface, and $800 \pm 10^{\circ}\text{C}$ on the front, side and back surfaces, respectively. The failure occurring outside the heated zone suggests that oxidative degradation may have been facilitated in a lower temperature regime. Figure 41 depicts this fracture surface. The planar fracture surface consisting of fibers with the interphase that appeared to have reacted to join neighboring fibers through solidification was observed on the corners and along the side edges, as shown in Figure 41C. The recession of the BN interphase is also apparent in other location of the oxidized area (Figure 41A). The silica overlayer formed on the surface as a result of the oxidation, shown in Figure 41A & B, observed in the area enclosed by the dotted line in the image showing the overall fracture surface. Finally, Figure 41D depicts the inner core of the material, in which the fiber pull-out was observed. The pullout length was relatively short.

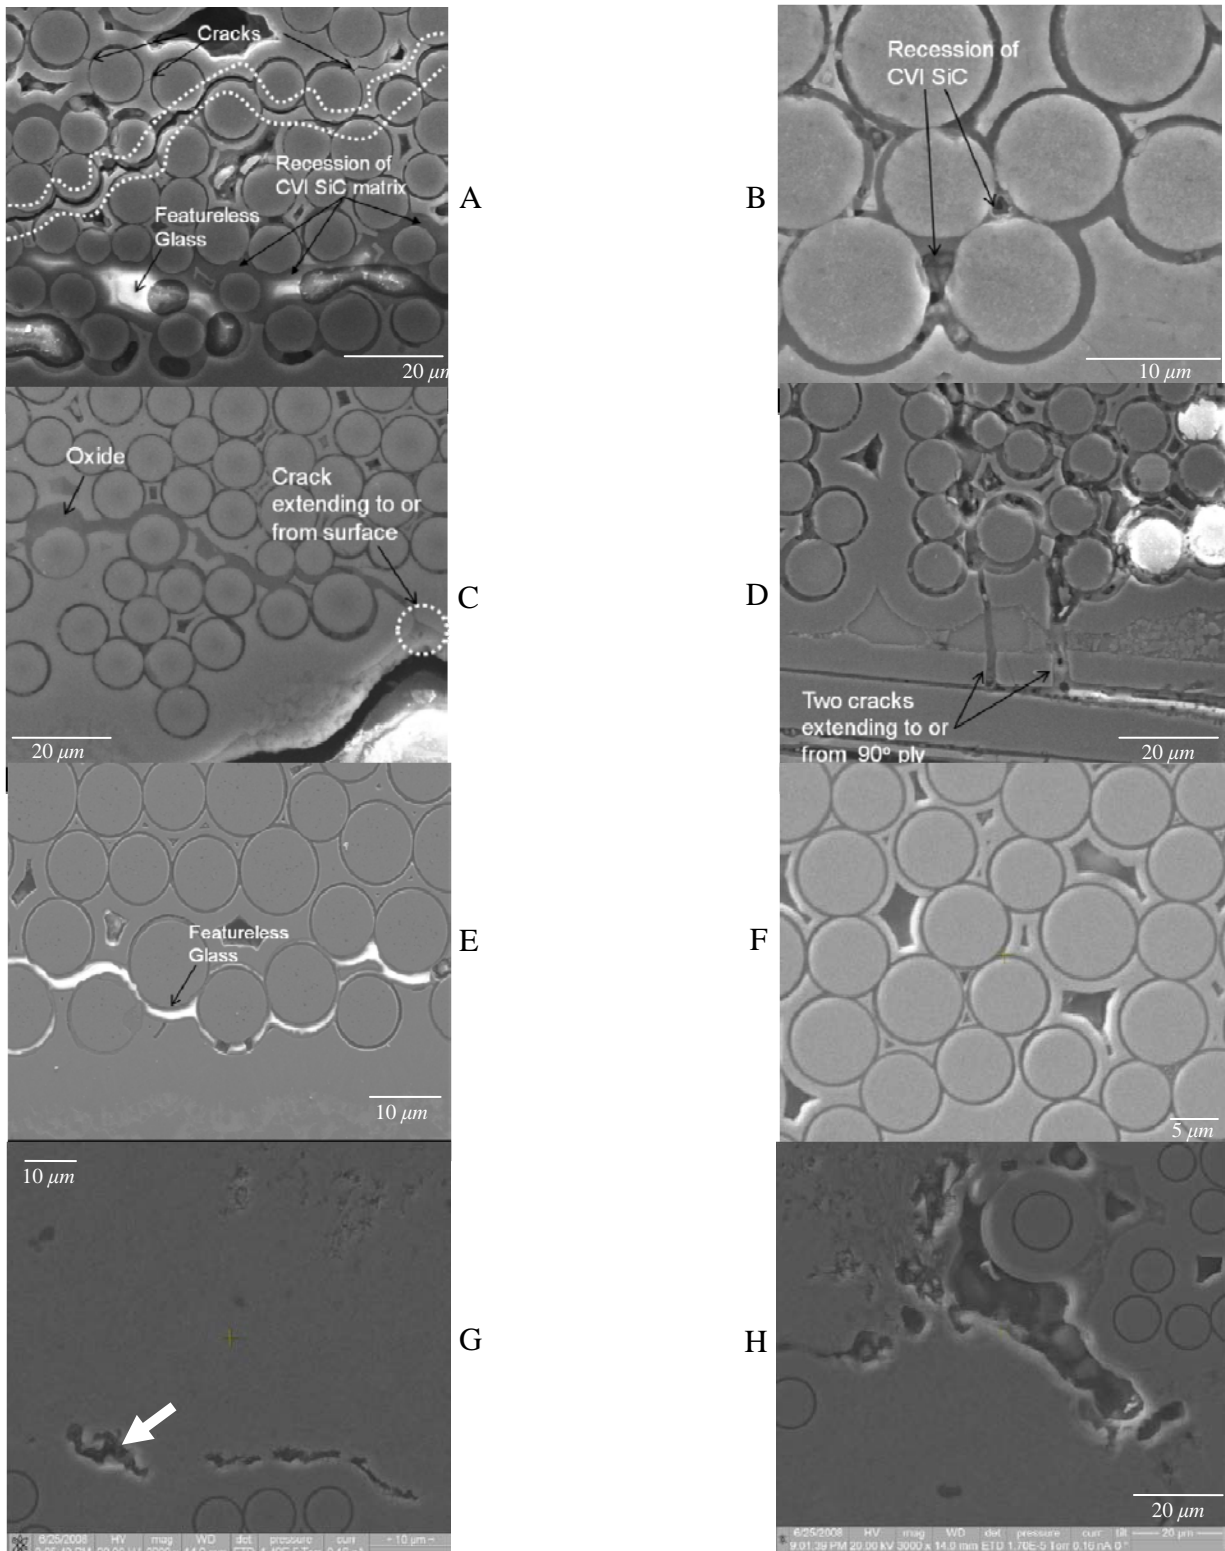
Figure 43: Microstructure of sectioned woven MI Syl-iBN/BN/SiC of runout specimen in the heated zone: A through H are from the oxidized and non-embrittled regions of the fracture surface as denoted on Figure 42

Another micrographic feature potentially associated with the degradation of material is the pores in the MI matrix as shown in Figure 43G and H. Imperfect infiltration of molten Si leaves some parts of the MI matrix unfilled, causing process-induced porosity. However, these pores observed here from the runout specimen showed apparent gradient in their distribution with respect to the distance from the flame impinged surface. Higher occurrence of the observed pores was detected from the plies close to the front surface. In addition, these observed pores showed boron, silicon and carbon contents according to the EDS analysis of the pore depicted by a white arrow shown in Figure 43G. Oxygen was also present, suggesting that the pores may have either been a byproduct of oxidative reactions or served as a diffusion path for permeating oxidants. For these reasons, the observed pores appeared to be induced by the applied test conditions and are referred to as “post-test observed pores.” Pores, regardless of their origins, introduce deleterious effects to the mechanical properties of a specimen. First, they facilitate the ingress of oxidants, making the material susceptible to oxidation. Secondly, they often have geometry with sharp apex, from which cracks initiated and branch out. Thirdly, they reduce the mechanical properties such as the modulus of elasticity (E) and fracture toughness.

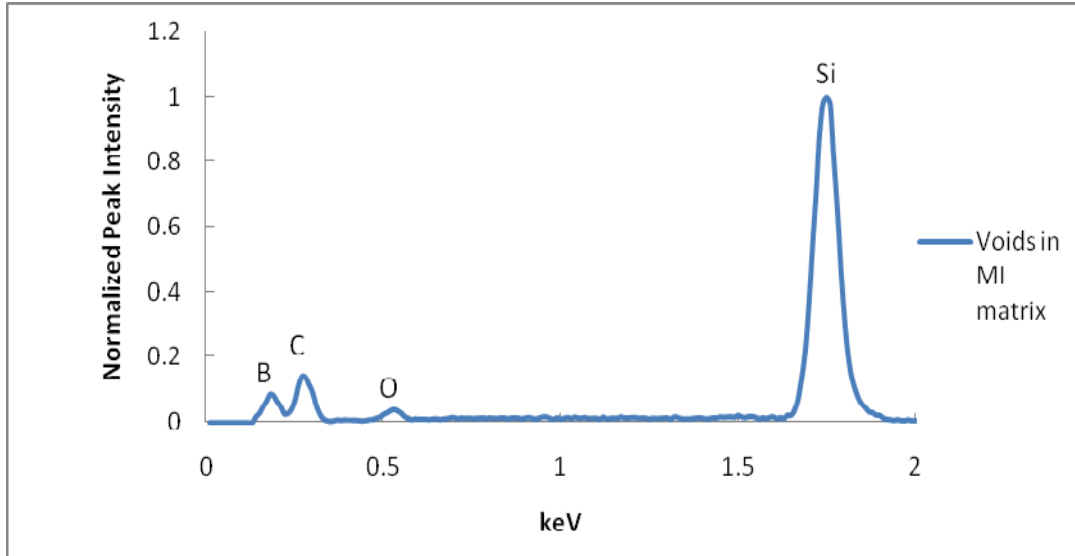
Figure 44: EDS analysis of the void in Figure 43G

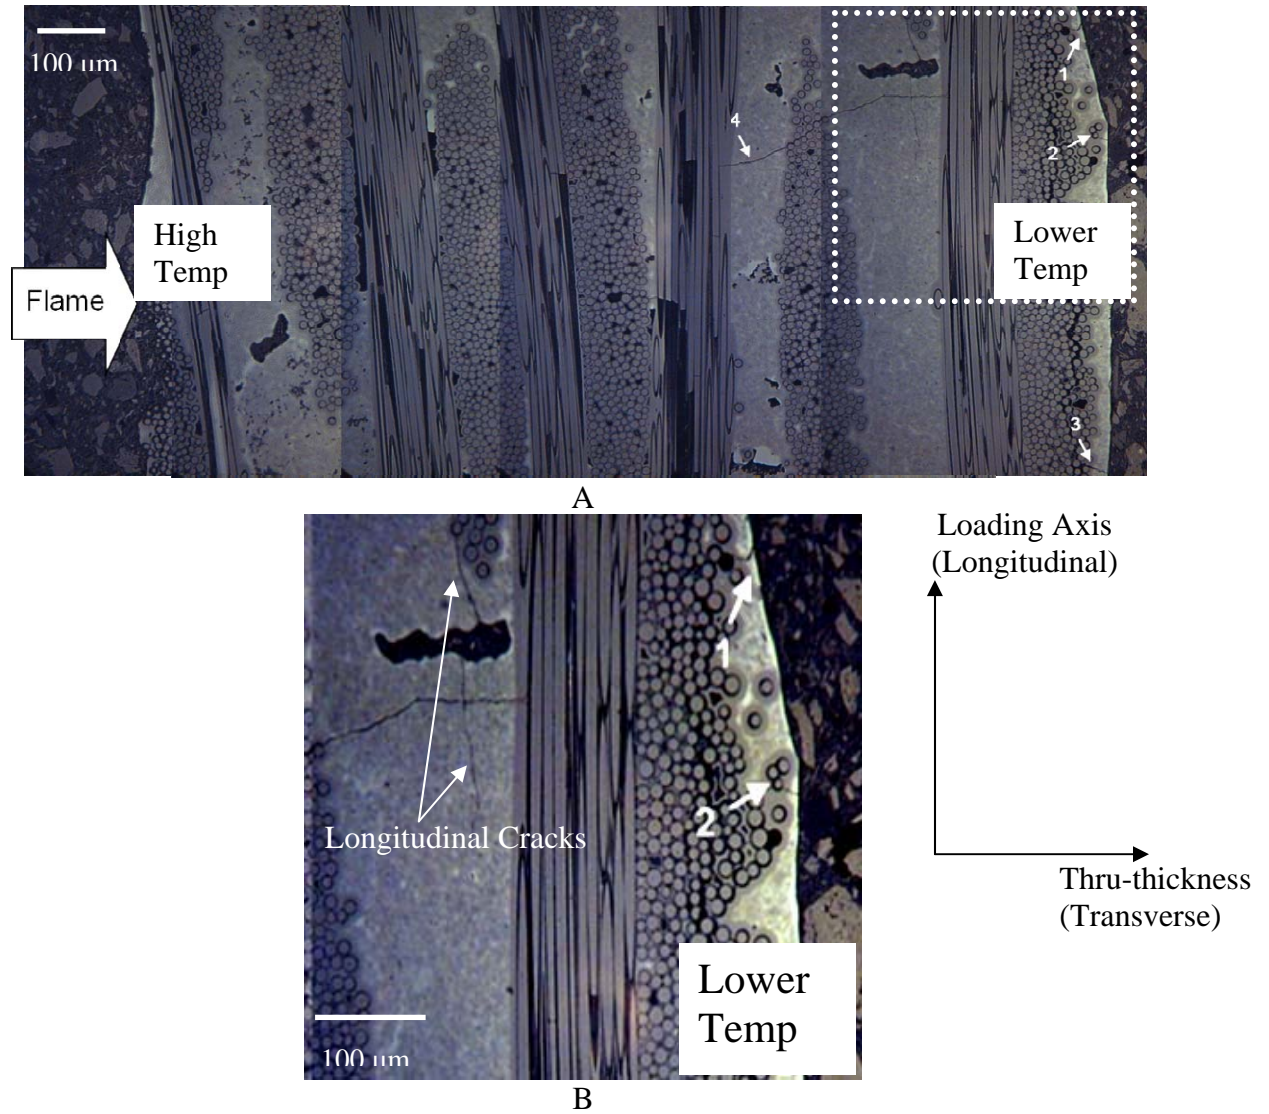
Figure 45: (A) Representative area on one of the four polished surfaces sectioned in parallel to the loading direction: (B) Close up view of the square zone enclosed in dotted line in (A)

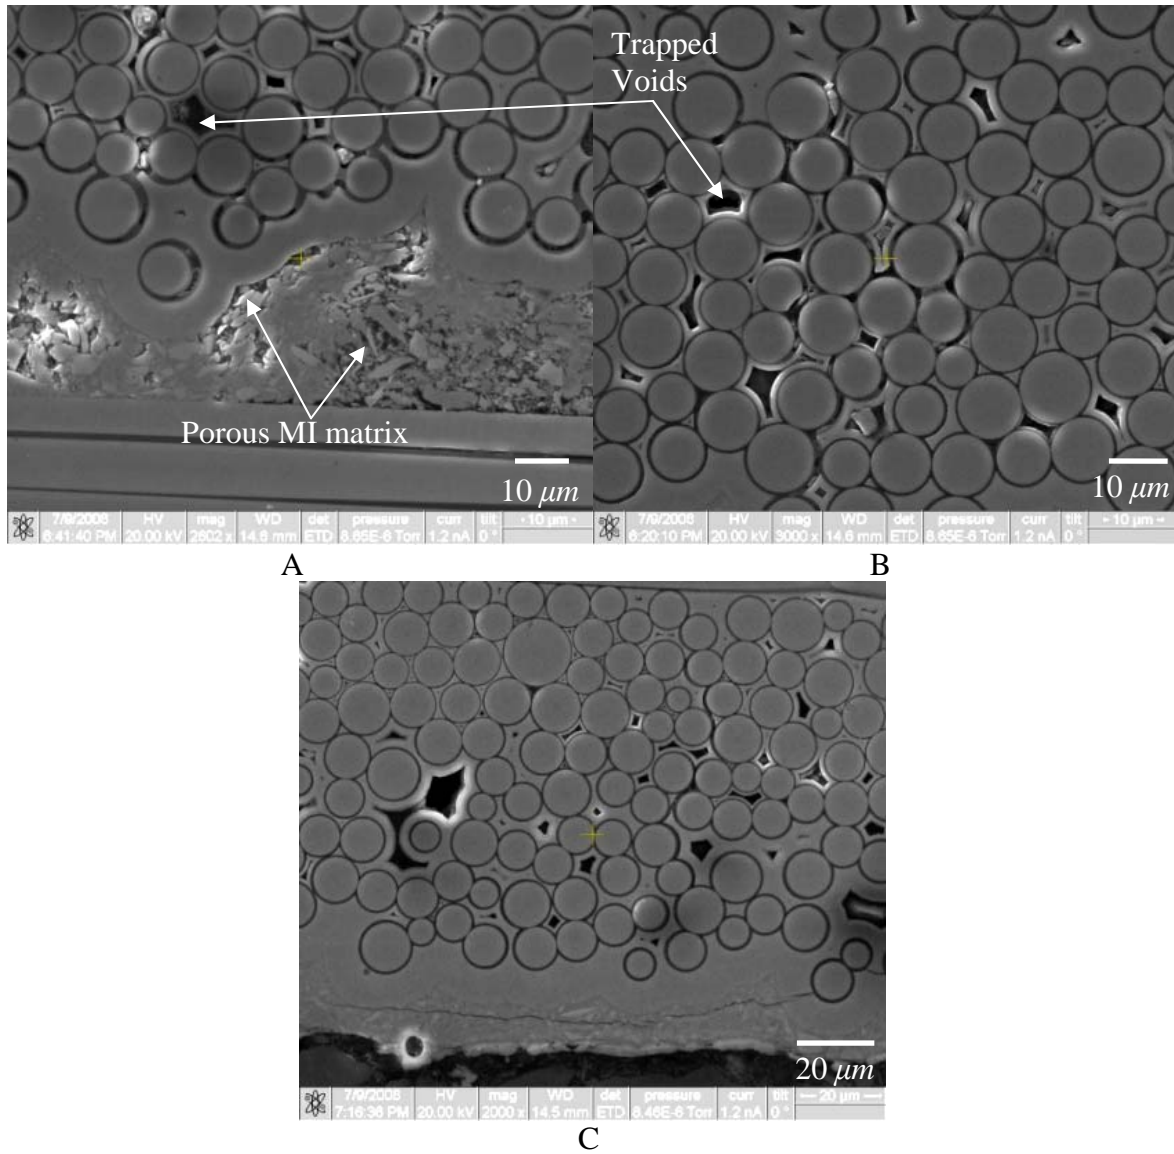
Figure 46: 90° ply at different depths: (A) surface level, (B) 2.0 mm deep and (C) 4.0 mm deep

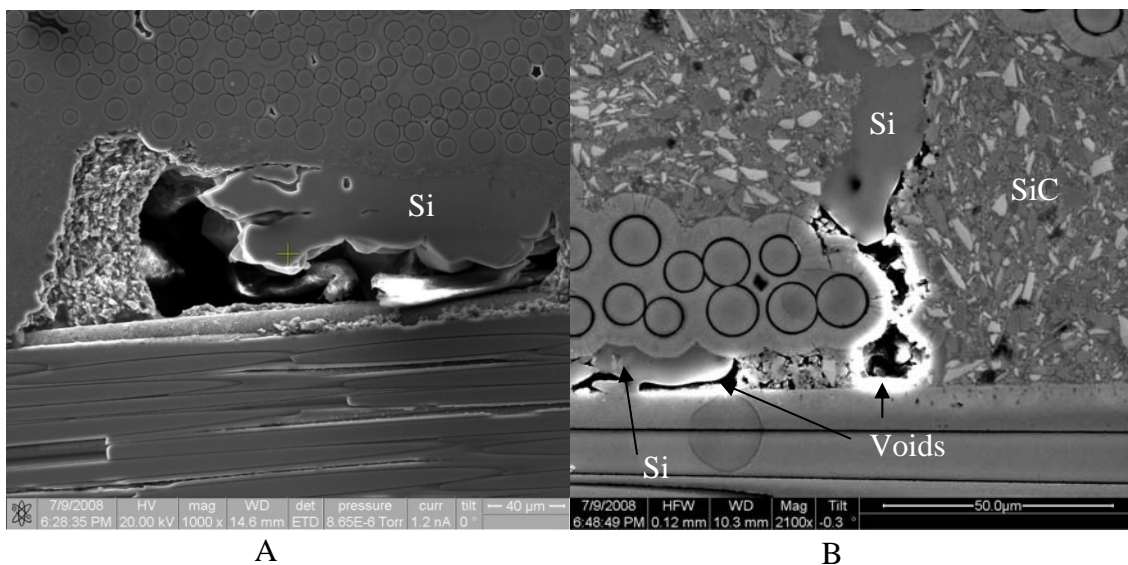
Figure 47: Voids observed from two different angles; (A) on a plane parallel to the loading direction and (B) on a plane perpendicular direction

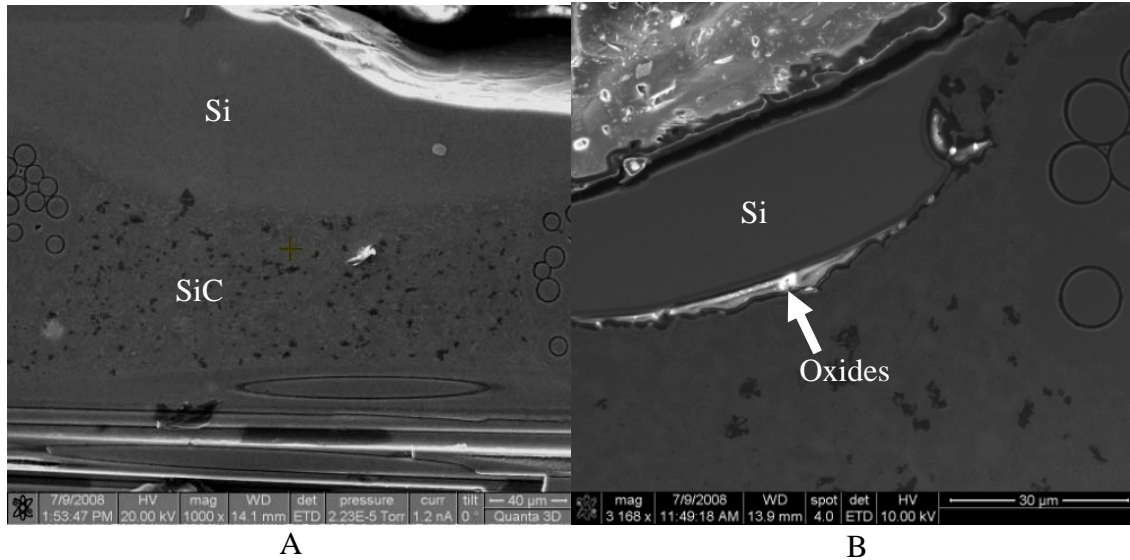
Figure 48: Separation of Si coating and subsequent oxidation: (A) Si coating coated on SiC matrix in pristine sample and (B) the Si coating found separated in the runout sample

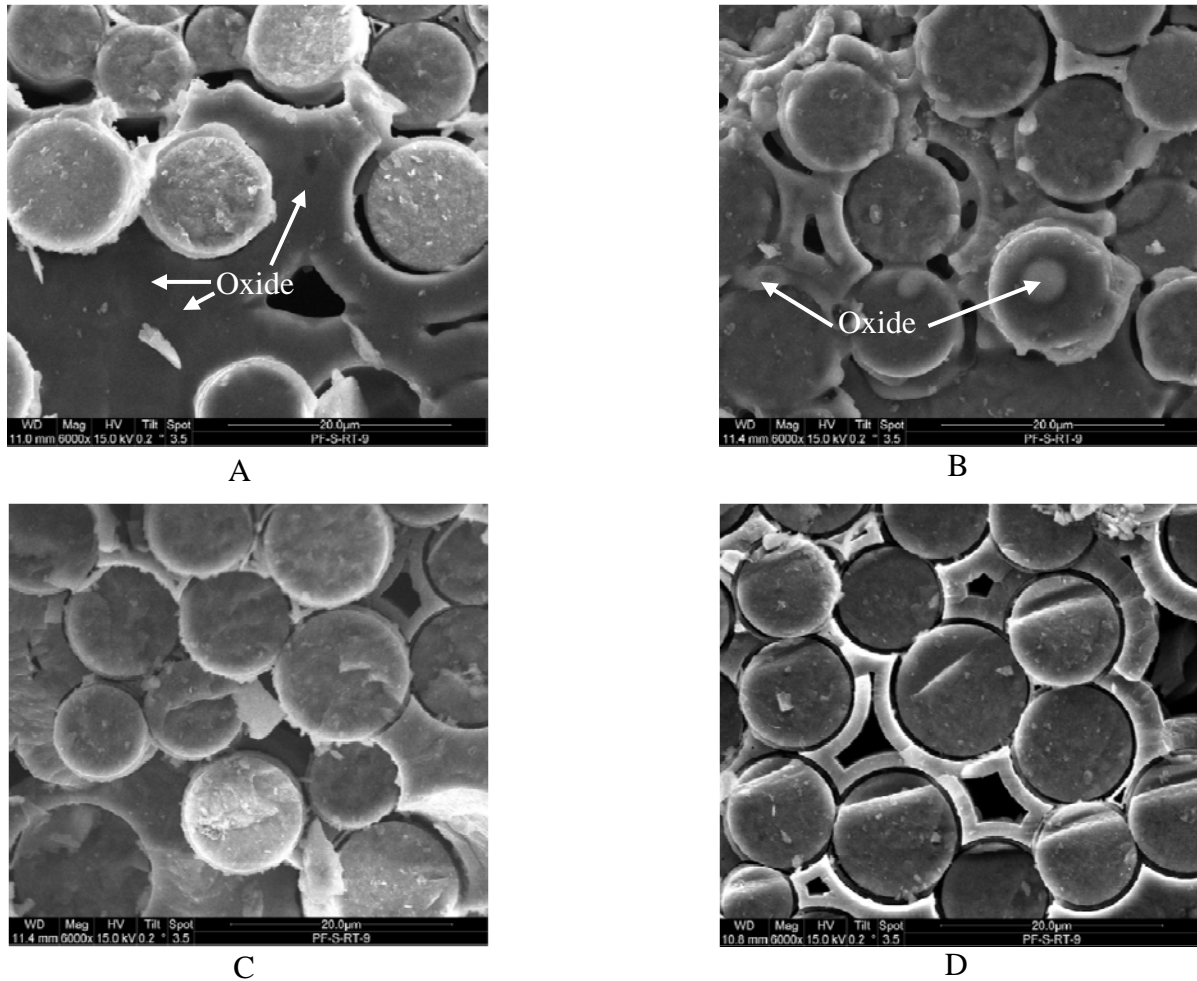
Figure 52: Microstructure of fatigued tested specimen under peak stress of 112% of *PL*: A and B are from the oxidized, C and D are from the non-embrittled regions of the fracture surface. Their specific locations are shown on Figure 51.

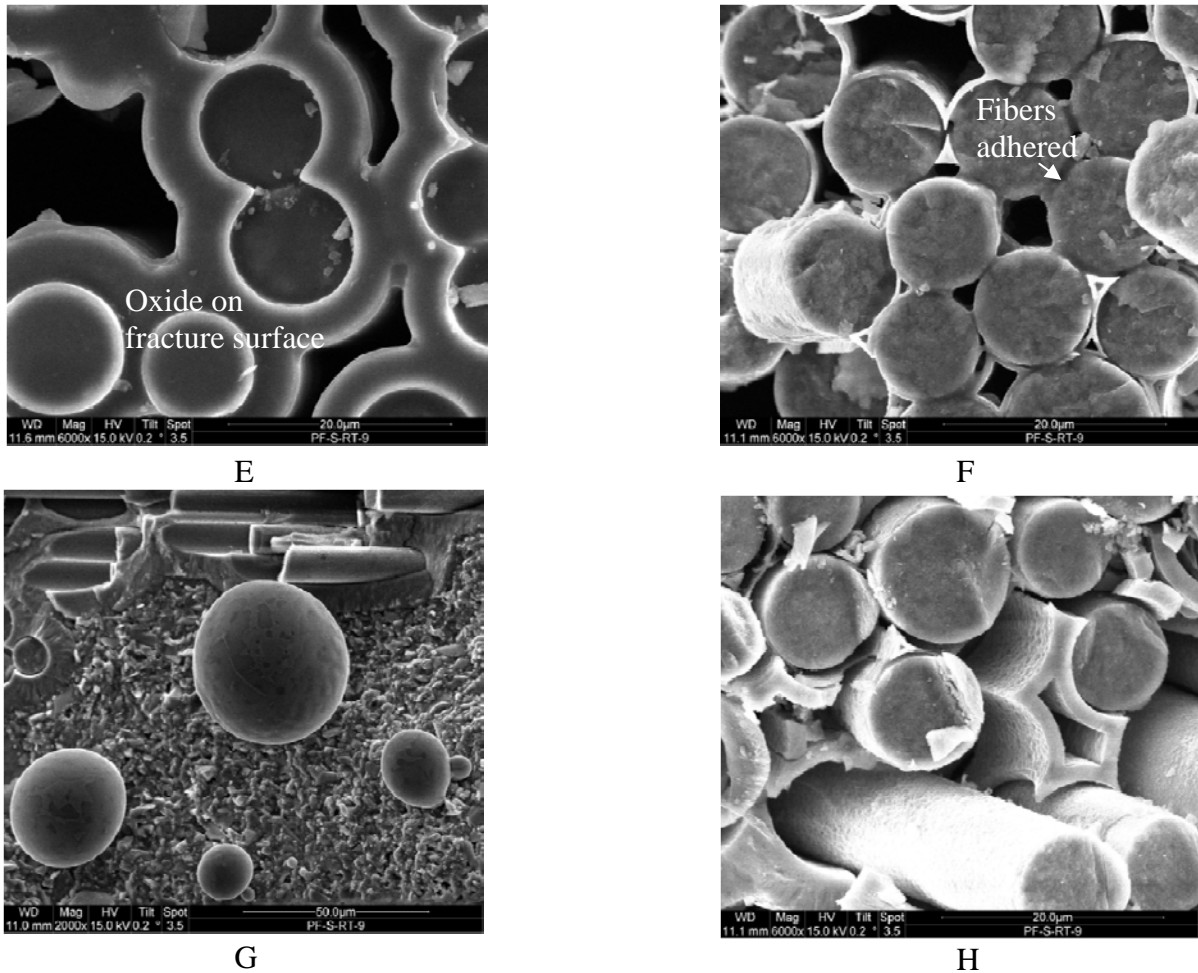
Figure 53: Microstructure of fatigued tested specimen under peak stress of 76% of *PL*: E and F are from the oxidized, G and H are from the non-embrittled regions of the fracture surface. Their specific locations are shown on Figure 51.

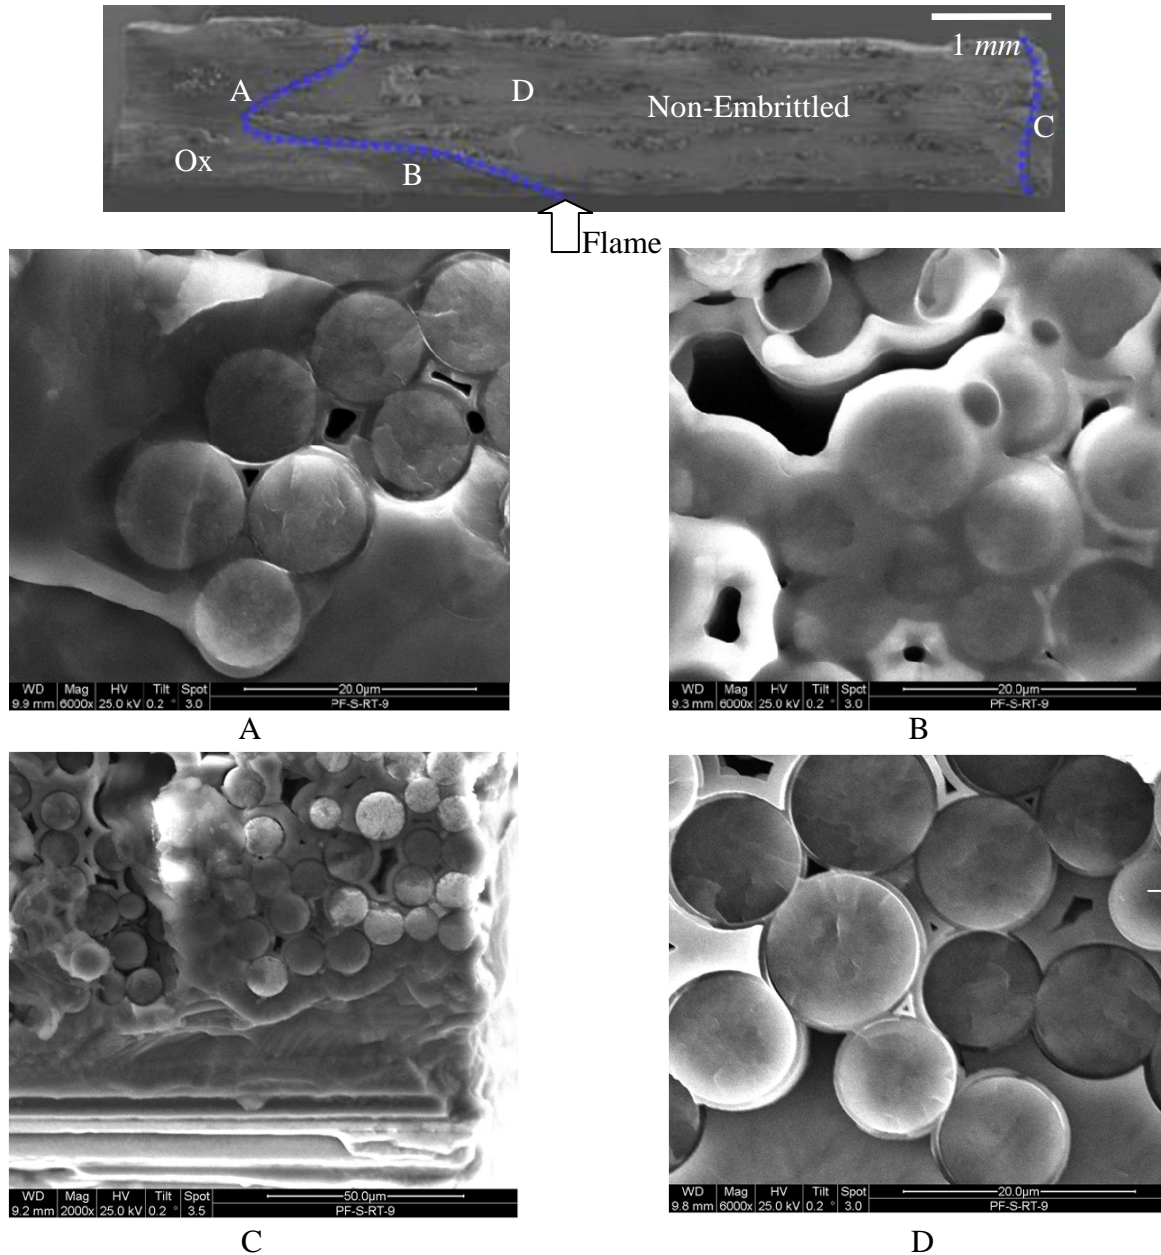
Figure 55: Fracture surface of the runout MI woven Syl/BN/SiC after residual strength test: A thru D are from the oxidized and non-embrittled regions of the fracture surface as denoted on the overall fracture surface shown above.
